Town of Arlington, Massachusetts

PART A – Executive Summary Self- Evaluation and Transition Plan

November 2019

Part A – Executive Summary

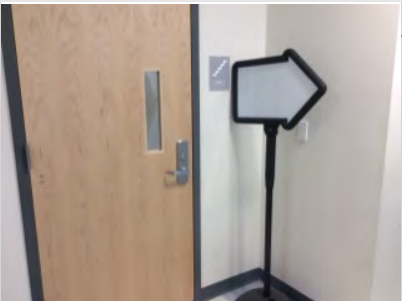
Maneuvering clearance(s) not provided	-	Remove the arrow sign to provide 18" clear on the latch pull side of the door.	1	Labor	\$0

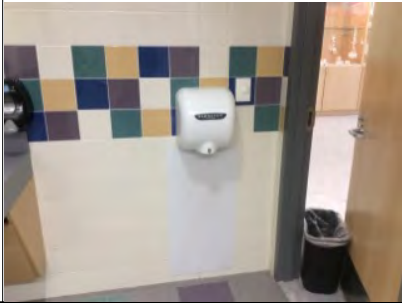
Dispenser acts as a protruding object	34"	Relocate the hand dryer out of the circulation path.	1	353	\$353
Access to Goods and Services												
15	Psychologist Office	1	101A	Dining or Work Surfaces	Work Surface

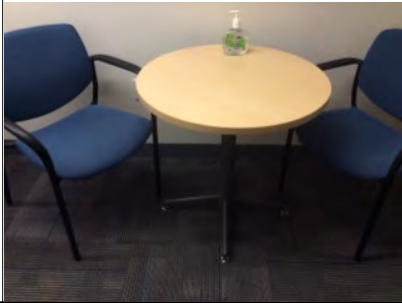
Knee or toe clearance not provided	-	Provide at least 1 work surface with 27" min. knee and toe clearance.	1	350	\$350
Access to Goods and Services												
16	Theater (Lower Level)	1	104	Assembly Area	N/A

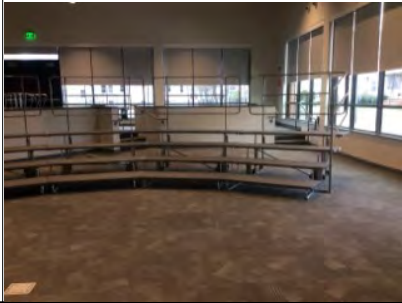
Number of seats Number of designated wheelchair spaces Minimum # wheelchair spaces not provided Wheelchair spaces overlap circulation paths	50 0 2	Provide bleachers with two (2) integrated wheelchair accessible spaces. (Cost estimate for a new 15' long aluminum bleacher and labor.)	1	3220	\$3220

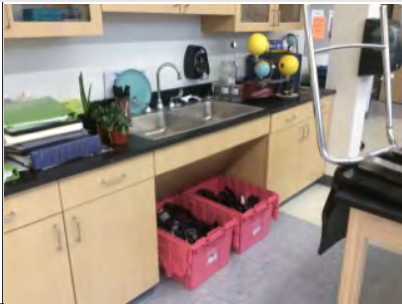
Clear floor space not provided at sink	-	Provide a 30" by 48" clear floor space positioned for a forward approach. Ensure the space under the sink is kept clear. Relocate stored objects.	2	Labor	\$0

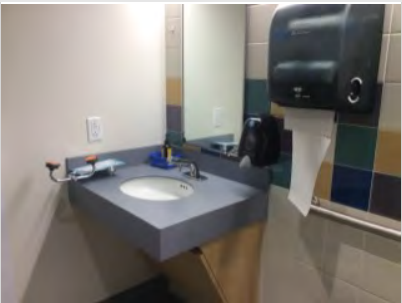
Dispenser controls > 42" high	51"	Relocate so the paper towel dispenser so the operable part is 42" max. above the finished floor. Ensure the paper towel dispenser is not mounted over the grab bar or in the circulation path.	1	353	\$353
Toilet & Bathing Rooms												
23	Toilet Room in Nurse's Office and Girls' Toilet Room 135	1	126 135	Dispensers	Hand Dryer

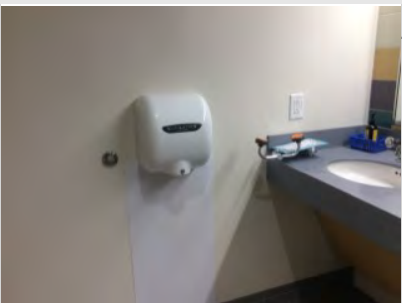
Dispenser acts as a protruding object	35"	Relocate the hand dryer out of the circulation path.	2	353	\$706

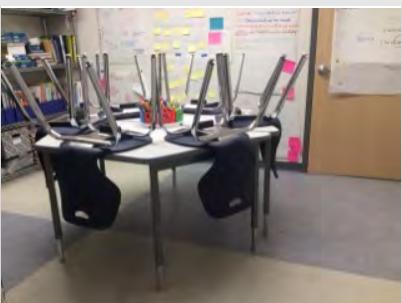
Access to Goods and Services												
24	Specialized Classroom	1	131	Dining or Work Surfaces	Work Surface

Not on a accessible route	-	Ensure the work surface is located on an accessible route. Currently the accessible portion of this table with 27" of knee clearance is not located on an accessible route. Relocate the table.	1	Labor	\$0

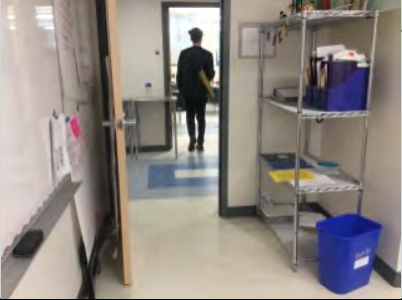
ID	Location	Floor	Room	Element	Type	Photo	Issues	Current Measure	Recommendations	Quantity	Price	Cost Estimation
25	Specialized Classroom	1	131	Doors, Doorways, & Gates	Classroom

Maneuvering clearance(s) not provided	12"	Remove the shelving unit to provide 18" clear on the latch pull side of the door.	1	Labor	\$0
Best Practice												
26	Classroom	1	135

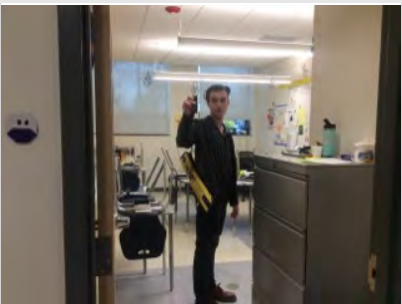
Obstructed by protruding objects	67"	Relocate decorations to be 80" min. from the finished floor.	1	Labor	\$0
28	Classroom	1	136	Signage	Designation

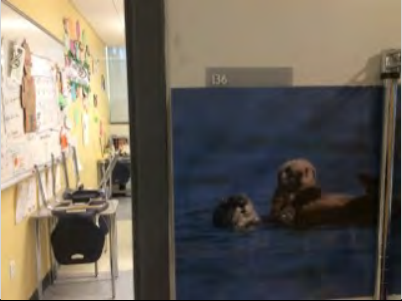
Signage blocked	-	Poster is currently blocking the braille on this sign. Relocate the poster.	1	Labor	\$0
Access to Goods and Services												
29	Vestibule to Exits 6 and 7	1	137	Doors, Doorways, & Gates	Emergency Egress

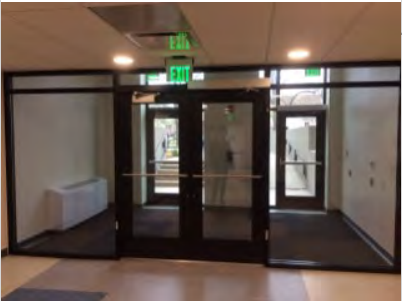
Mat not securely attached	-	Secure the mat.	1	Labor	\$0

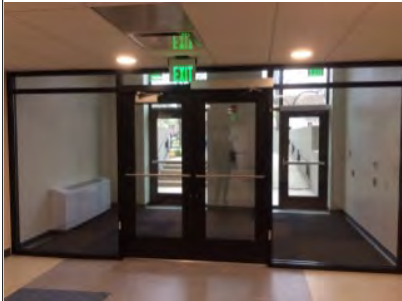
ID	Location	Floor	Room	Element	Type	Photo	Issues	Current Measure	Recommendations	Quantity	Price	Cost Estimation
Approach and Entrance												
30	Exits 6, 7, Exit 4 and Main Lobby	1	137 152	Emergency Exit	N/A

International Symbol of Acc. not provided	-	Provide an illuminated International Symbol of Accessibility at the accessible exits.	4	116	\$464
Access to Goods and Services												
31	Main Lobby	1	152	Interior Access Route	N/A

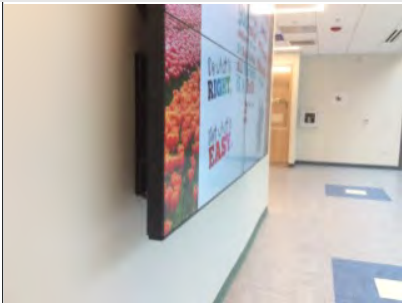
Obstructed by protruding objects	7.5"	Provide a cane-detectable barrier at each side of the television.	2	153	\$306
Access to Goods and Services												
32	Gym	2		Assembly Area	N/A

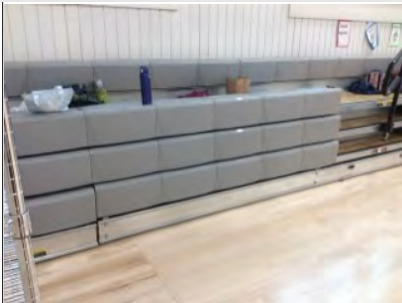
Number of seats Number of designated wheelchair spaces Minimum # wheelchair spaces not provided	36 0 2	Provide bleachers with two (2) integrated wheelchair accessible spaces. (Cost estimate for a new 15' long aluminum bleacher and labor.)	1	3220	\$3220
Access to Goods and Services

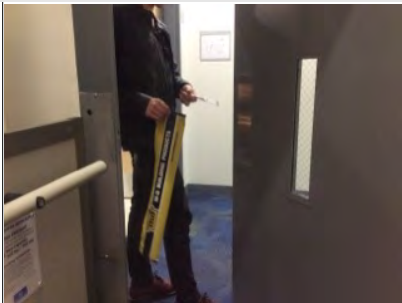
33	Lift in Media Center	2		Doors, Doorways, & Gates	Other

Door requires > 5 lbs. of force to open	17 lbs.	Adjust closers so doors do not require more than 5 pounds of force to open.	1	Labor	\$0

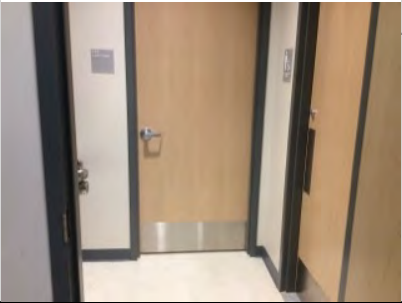
Maneuvering clearance(s) not provided		Provide an automatic door opener at the toilet room door.	1	1530	\$1530
Access to Goods and Services												
36	Gym, Exit to Stair 1	2	200	Means of Egress	N/A

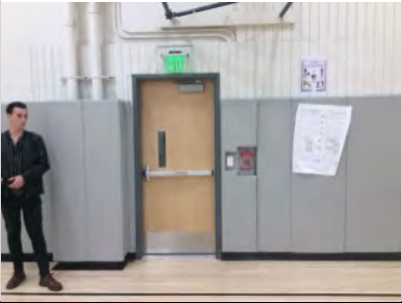
Tactile exit sign not provided	-	Ensure tactile exit signs with raised characters and braille are provided at exit doors. Mount signs between 48"- 60" above finished floor located on the latch side of the door.	1	116	\$116
Access to Goods and Services												
37	Art Room	2	201	Signage	Designation

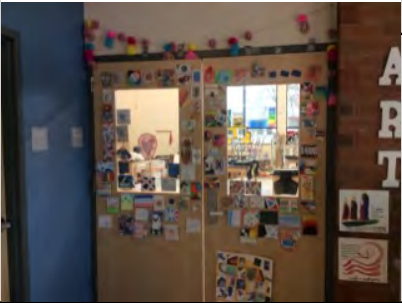
Sign not located on the latch side of the door	-	Locate sign at permanent rooms alongside the door on the latch side.	1	Labor	\$0

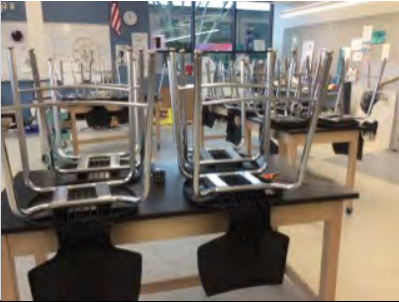
ID	Location	Floor	Room	Element	Type	Photo	Issues	Current Measure	Recommendations	Quantity	Price	Cost Estimation
38	Art Room	2	201	Dining or Work Surfaces	Work Surface

Knee or toe clearance not provided	17.5"	Provide at least 1 work surface with 27" min. knee and toe clearance. (The horizontal post interferes with the clearance which should be 19 inches deep min.)	1	440	\$440
Access to Goods and Services												
39	Specialized Classroom	2	202A	Doors, Doorways, & Gates	Classroom

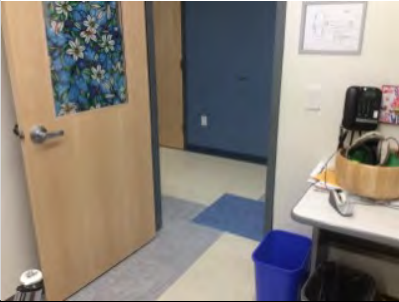
Maneuvering clearance(s) not provided	12"	Relocate table and bin to provide 18" clear on the latch pull side of the door.	1	Labor	\$0
Access to Goods and Services												
40	School Counselor	2	204	Dining or Work Surfaces	Work Surface

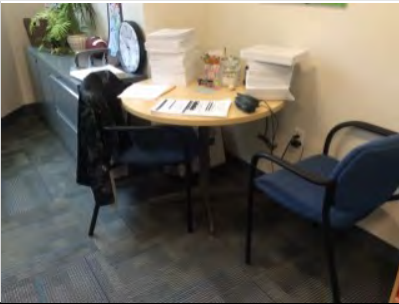
Knee or toe clearance not provided	-	Provide at least 1 work surface with 27" min. knee and toe clearance.	1	350	\$350
41	School Counselor	2	204	Doors, Doorways, & Gates	N/A

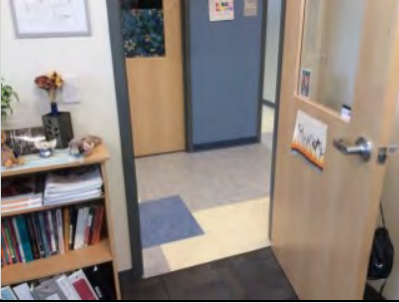
Maneuvering clearance(s) not provided	5"	Relocate bookshelf to provide 18" clear on the latch pull side of the door.	1	Labor	\$0

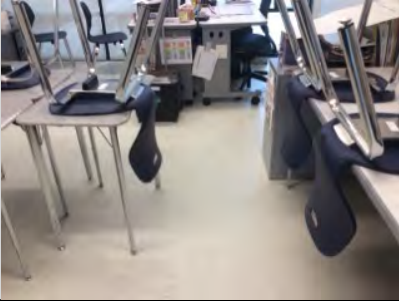
Access to Goods and Services												
42	Classroom	2	206	Interior Access Route	N/A

Route < 36" wide	30.5"	Ensure that a clear width of 36" min. is maintained at the accessible route. Relocate furniture.	1	Labor	\$0

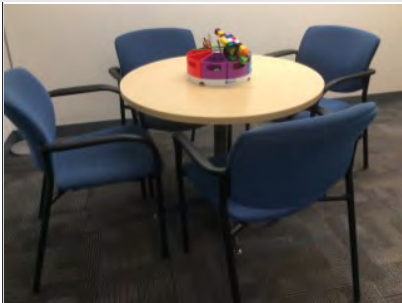
Knee or toe clearance not provided	-	Provide at least 1 work surface with 27" min. knee and toe clearance.	1	350	\$350
Access to Goods and Services												
45	Science Room	2	216	Dining or Work Surfaces	Work Surface

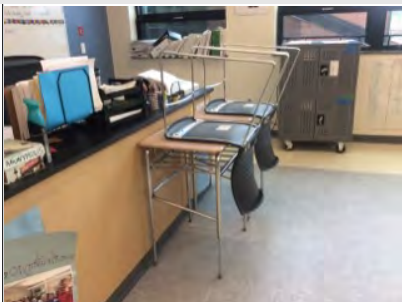
At least one or 5% accessible tables not provided Knee or toe clearance not provided	- 24"	Ensure that at least one work surface is accessible. Provide at least 1 work surface with 27" min. knee and toe clearance.	1	350	\$350

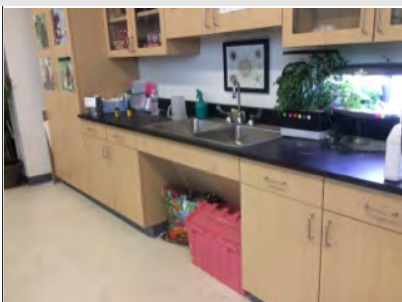
Additional Access												
46	Science Classroom	2	218	Sink	Classroom

Clear floor space not provided at sink	-	Provide a 30" by 48" clear floor space positioned for a forward approach. Ensure the space under the sink is kept clear. Relocate stored objects.	1	Labor	\$0

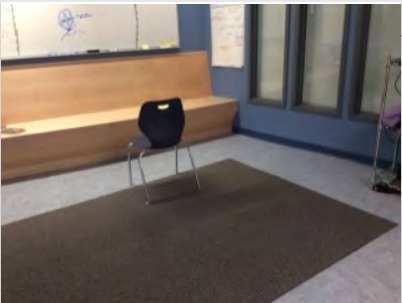
Mat not securely attached	-	Secure the mat.	1	Labor	\$0
Toilet & Bathing Rooms												
49	At Both Single-User Toilet Rooms By 305	3		Dispensers	Hand Dryer

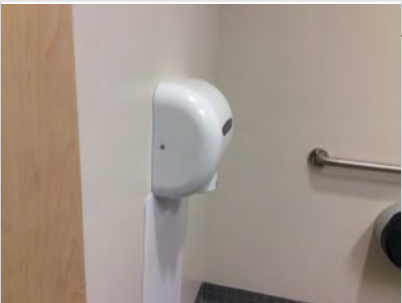
Dispenser acts as a protruding object	36.25"	Both toilet rooms should resolve protruding object issues. Relocate the hand dryer out of the circulation path.	2	353	\$706
Access to Goods and Services												
50	At One Single-User Toilet Room By 305	3		Doors, Doorways, & Gates	Toilet Room

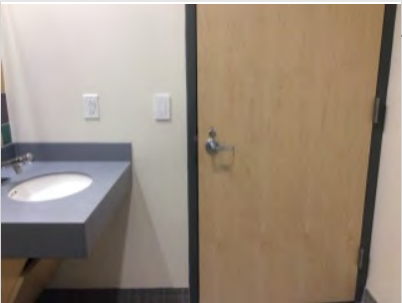
Maneuvering clearance(s) not provided	14"	At least one of these toilet rooms must be compliant. Provide an automatic door opener at one, and at the toilet room without the automatic door opener, replace the sign with a sign that does not contain the International Symbol of Accessibility (ISA).	1	1646	\$1646

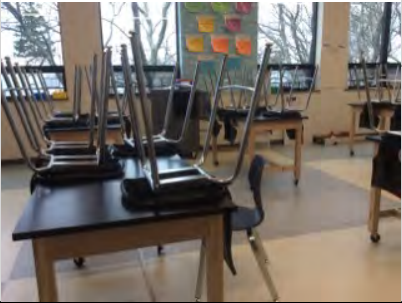
At least one or 5% accessible tables not provided Knee or toe clearance not provided	- -	Provide at least 1 work surface with 27" min. knee and toe clearance in the science labs.	1	440	\$440
Access to Goods and Services												
53	Elevator Near 306	3	306	Elevator	Interior

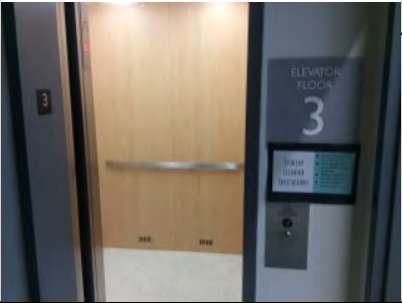
Door clear width off-centered < 36"	33"	Repair may require major renovation at elevator cab and hoistway and may not be practical until system is replaced.	1	-	\$0

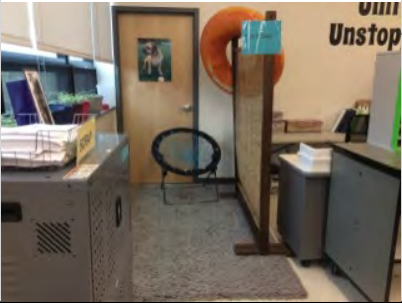
Access to Goods and Services												
54	Classrooms	3	307, 305	Doors, Doorways, & Gates	Classroom

Mat not securely attached	-	Secure the mats.	2	Labor	\$0

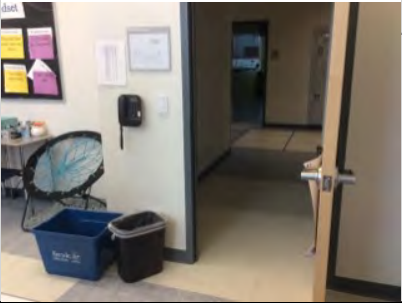
Maneuvering clearance(s) not provided	-	Remove the trash can and bin to provide 18" clear on the latch pull side of the door.	10	Labor	\$0
Best Practice												
57	Corridor Lockers	3,2,1

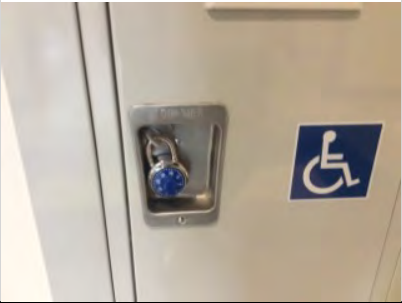
Best Practice: If padlocks are provided by school, provide an option that is easier to operate for students who request them.	1	-	\$0
Best Practice												
58	Community Garden	Ext.

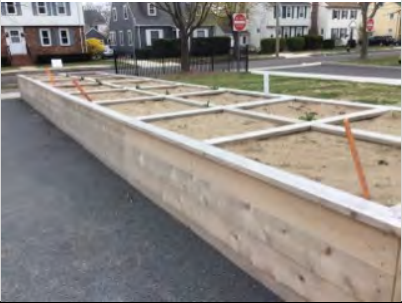
Best Practice: The IHCD team is encouraged to see that raised garden beds have been provided for students. Consider also providing an additional raised planter for seated users with knee and toe clearance mounted 27" above the ground.	1	-	\$0

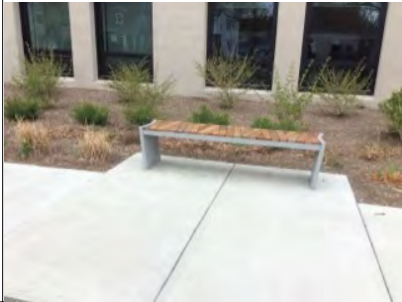
-	Best Practice: Provide a bench in a location that allows for a clear floor space of 36" wide min. by 48" deep min. Ensure that there can be shoulder alignment between a person seated on the bench and a person seated alongside the bench using a wheelchair. The shoulder alignment of the wheelchair space should be measured 36" from the front of the wheelchair space.	1	-	\$0
Best Practice												
60	Exit 14 on Foster Street	Ext.

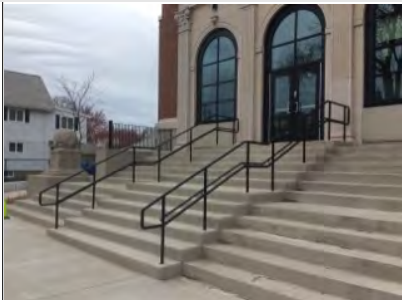
-	Best Practice: Although the stepped exit on Foster Street is no longer used as an entrance, it is located at the entry plaza and may be mistaken for one. It would be helpful to provide a directional sign at the base of the stairs to direct people to the nearest accessible entrance. (\$173)	1	-	\$0

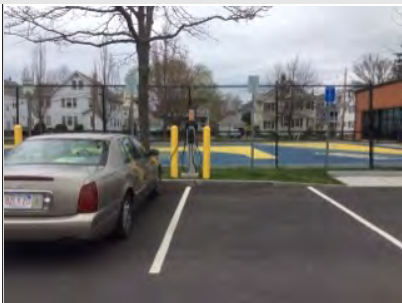
Best Practice												
61	Parking Lot Electric Vehicle Charging Station	Ext.			N/A

Best Practice: Consider providing a 3' min. access aisle around at least one (1) electric vehicle charging station. Ensure this route connects to the charging port.	1	-	\$0
Approach and Entrance												
62	Passenger Loading Zone	Ext.		Passenger Loading Zones	N/A

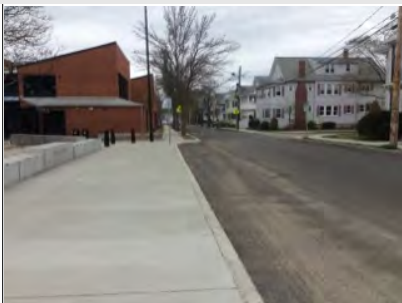
Zone not connected to an accessible route Marking not provided at access aisle	- -	Ensure the passenger loading zone is connected to an accessible route. Provide a curb ramp. Ensure access aisles are marked to discourage parking in them.	1	3804	\$3804

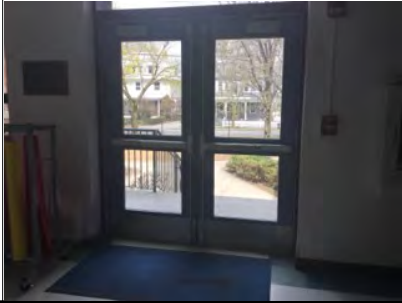
Tactile exit sign not provided Directional sign to accessible emergency exit not provided	- -	Provide a directional sign indicating the location of the nearest emergency exit. Provide a tactile exit sign with raised characters and braille at exit doors. Mount signs between 48"- 60" above finished floor located on the latch side of the door.	2	116	\$232
Access to Goods and Services												
2	Classroom	1	101A	Doors, Doorways, & Gates	Classroom

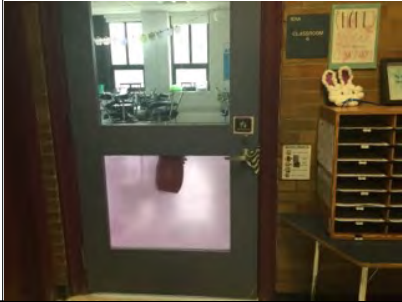
Maneuvering clearance(s) not provided	3.5"	Relocate table and shelf to ensure 18" clear on the latch pull side of the door and clear floor space at the sign.	1	Labor	\$0
Access to Goods and Services												
3	Reading Room	1	104A	Interior Access Route	N/A

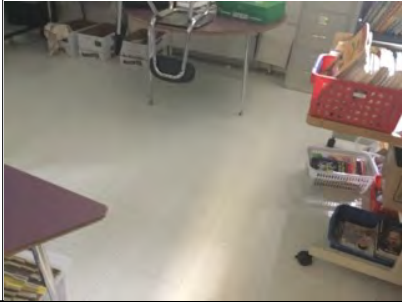
Route < 36" wide	27.5"	Ensure that a clear width of 36" min. is maintained at the accessible route. Relocate furniture.	1	Labor	\$0

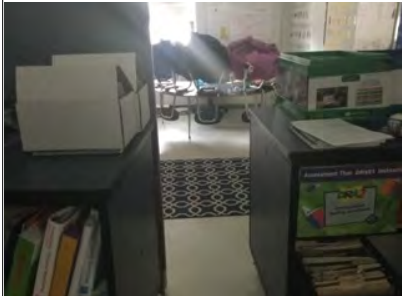
4	Reading Room	1	104A	Interior Access Route	N/A

Route < 36" wide	17"	Ensure that a clear width of 36" min. is maintained at the accessible route. Relocate furniture.	1	Labor	\$0

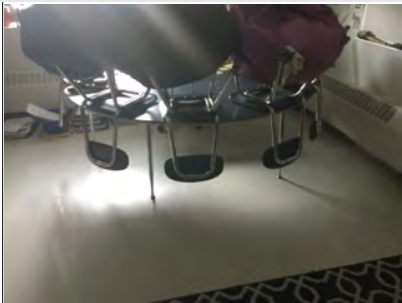
At least one or 5% accessible tables not provided	22.5"	Ensure that at least one work surface is accessible with 24" high of knee and toe clearance min.	2	350	\$700
Access to Goods and Services												
7	Library/ Instructional Materials Center	1	105A	Signage	Designation

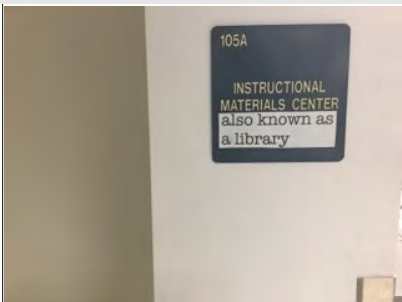
Braille not provided	- -	Ensure that braille is not obscured by paper sign. Best Practice: Consider simplifying language to say "Library."	1	Labor	\$0
Access to Goods and Services

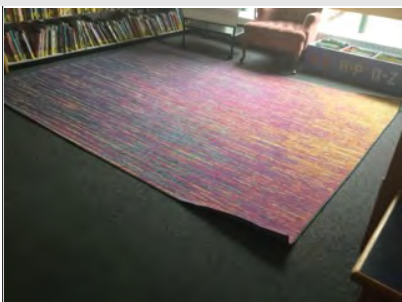
8	Library/ Instructional Materials Center	1	105A	Interior Access Route	N/A

Surface not stable, firm, and slip-resistant	-	Securely attach mat.	1	Labor	\$0

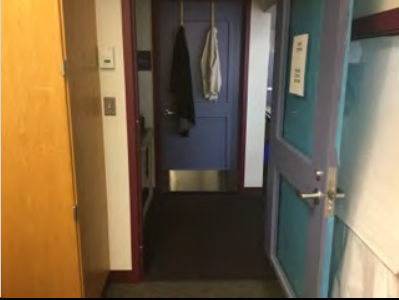
Maneuvering clearance(s) not provided	8"	Remove the cabinet so there this 18" minimum on the latch pull side of the door.	1	Labor	\$0
10	MCAS Testing Office	1	105B	Interior Access Route	N/A

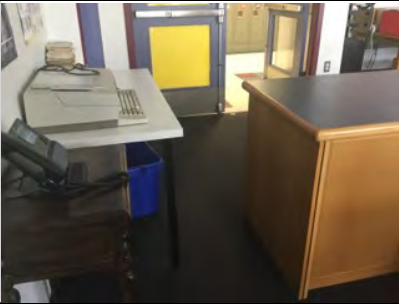
Route < 36" wide	17.5"	Ensure that a clear width of 36" min. is maintained at the accessible route. Rearrange furniture.	1	Labor	\$0
Access to Goods and Services												
11	OT Room	1	105E	Interior Access Route	N/A

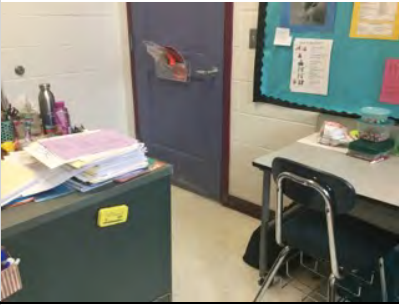
Route < 36" wide	15"	Ensure that a clear width of 36" min. is maintained at the accessible route. Relocate furniture.	1	Labor	\$0
12	OT Room	1	105E	Doors, Doorways, & Gates	Other

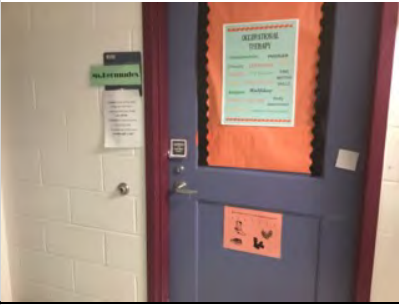
Door requires > 5 lbs. of force to open	13 lbs.	Adjust closers so doors do not require more than 5 pounds of force to open.	1	Labor	\$0

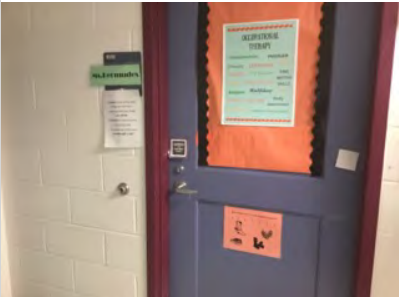
13	OT Room	1	105E	Signage	Designation

Raised characters not provided Braille not provided	- -	Remove any material that covers the sign. Always ensure the signs with raised characters and braille are not covered.	1	Labor	\$0

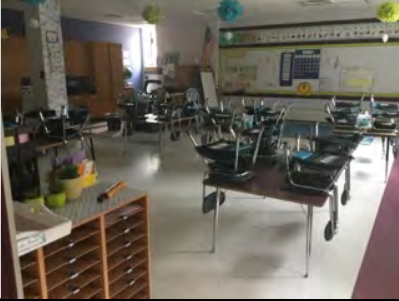
Surface not stable, firm, and slip-resistant	-	Securely attach mat.	1	Labor	\$0
15	Classroom 8	1	108 / 117	Doors, Doorways, & Gates	Classroom

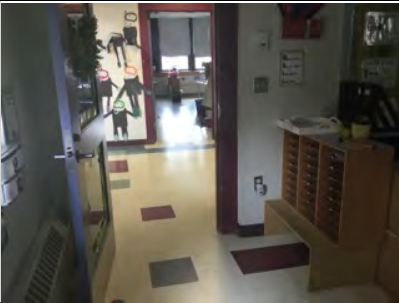
Maneuvering clearance(s) not provided	-	Relocate shelves and other items to ensure 18" clear on the latch pull side of the door.	1	Labor	\$0
Toilet Rooms for Children												
16	Kindergarten Classroom 1 Toilet Room	1	110A / 120	Toilet Compartment	Accessible Compartment

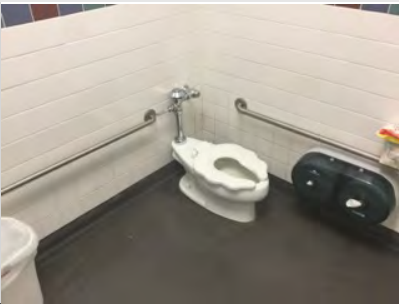
Non-compliant toilet paper dispenser	12"	Replace toilet paper dispenser as it does not allow continuous paper flow. Ensure that dispenser controls are located no lower than 14" above the finished floor.	1	353	\$353
Access to Goods and Services												
17	Kindergarten Classroom 1	1	110A / 120	Dining or Work Surfaces	Work Surface

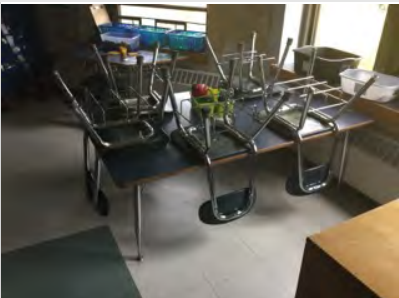
At least one or 5% accessible tables not provided	19.75"	Ensure that at least one work surface is accessible with 24" high of knee and toe clearance min.	1	350	\$350

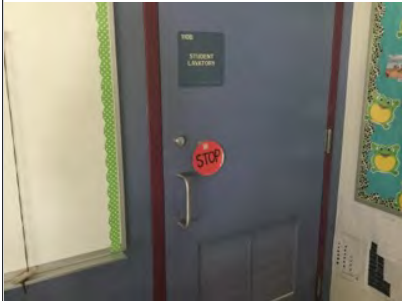
Sign not located on the latch side of the door	-	Locate sign at permanent rooms alongside the door on the latch side.	1	Labor	\$0
Access to Goods and Services												
19	Kindergarten Classroom 1, Kindergarten Classroom 3, Kindergarten Classroom 2	1	110A / 120 121 122	Interior Access Route	N/A

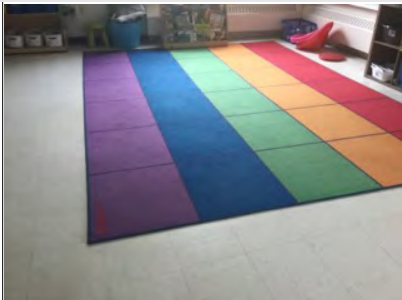
Surface not stable, firm, and slip-resistant	-	Securely attach mats.	4	Labor	\$0
Access to Goods and Services												
20	Kindergarten Classroom 2 Toilet Room	1	111	Doors, Doorways, & Gates	Toilet Room

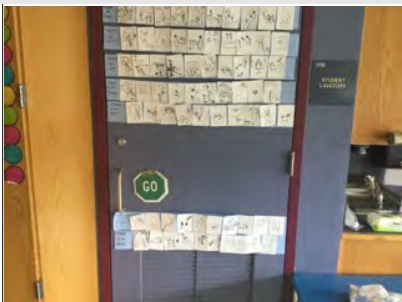
Maneuvering clearance(s) not provided	-	Relocate cabinet to ensure 18" clear on the pull side of the door.	1	Labor	\$0
Access to Goods and Services												
21	Kindergarten Classroom 2	1	111	Interior Access Route	N/A

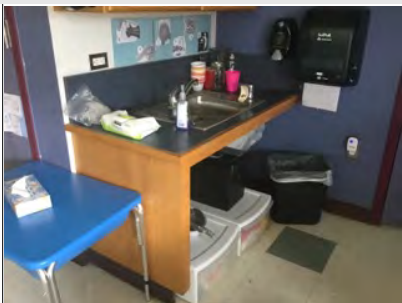
Obstructed by protruding objects Not operable with a closed fist	- -	Relocate paper towel dispenser out of the circulation path. Provide a paper towel dispenser that can be operable with a closed fist.	1	628	\$628

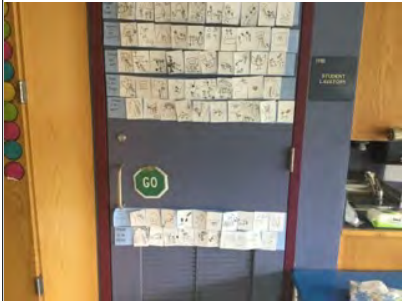
Sign not located on the latch side of the door	-	Locate sign at permanent rooms alongside the door on the latch side.	1	Labor	\$0
Additional Access												
23	Kindergarten Classroom 2	1	111 / 116	Sink	Classroom

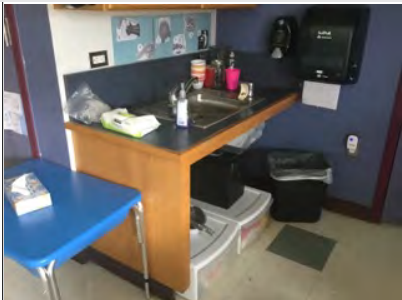
Toe and knee clearances not provided	-	Ensure there is knee clearance positioned for a forward approach by relocating the storage bins. 18" deep at the sink is not entirely compliant, but usable.	1	Labor	\$0
Best Practice												
24	Kindergarten Classroom 2	1	111 / 116

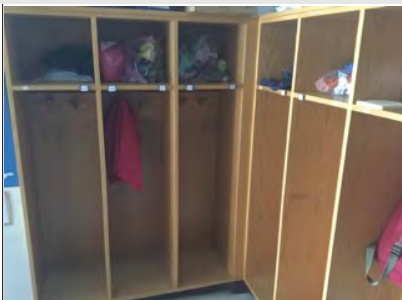
48"	Best Practice: Provide at least one coat hook and shelf that is 36" maximum above the finished floor.	1	-	\$0
Toilet Rooms for Children												
25	Kindergarten Classroom 2 Toilet Room	1	111 / 116	Single-User Toilet	N/A

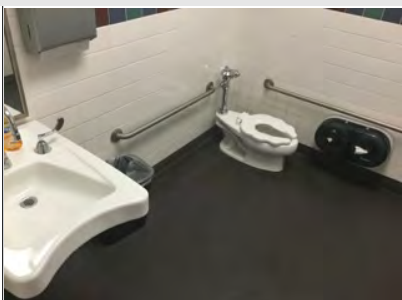
Non-compliant toilet paper dispenser	13"	Replace toilet paper dispenser as it does not allow continuous paper flow. Ensure that dispenser controls are located no lower than 14" above the finished floor.	1	353	\$353

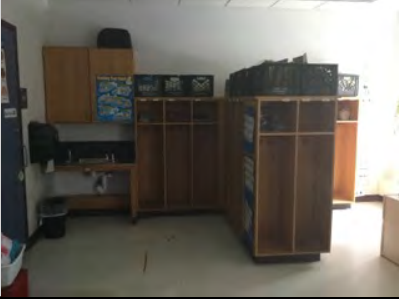
48"	Best Practice: Provide at least one coat hook and shelf that is 36" maximum above the finished floor.	1	-	\$0
Best Practice												
27	Kindergarten Classroom 3 (Sign to Computer Lab)	1	114D

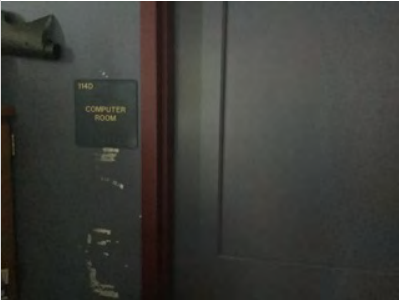
-	Best Practice: Sign does not reflect the current use of the room. Consider replacing sign.	1	-	\$0
Access to Goods and Services												
28	Reading Room	1	116A	Doors, Doorways, & Gates	Meeting Room

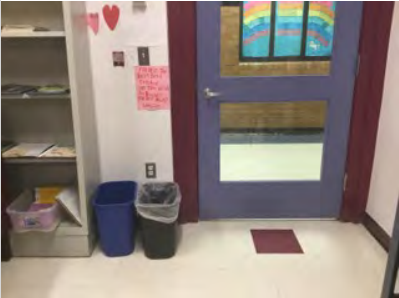
Maneuvering clearance(s) not provided	-	Relocate trash bin to ensure 18" clear on the latch pull side of the door.	1	Labor	\$0
29	Reading Room	1	116A	Interior Access Route	N/A

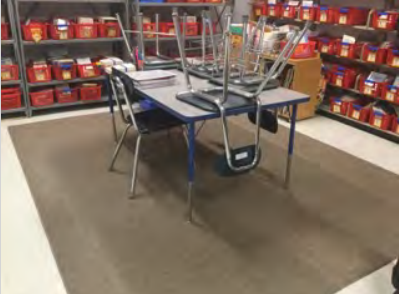
Surface not stable, firm, and slip-resistant	-	Securely attach mat.	1	Labor	\$0

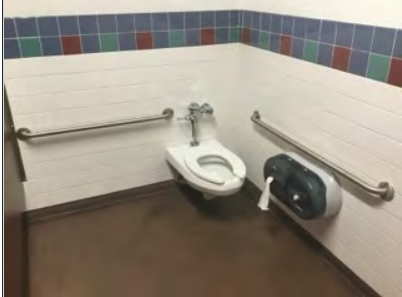
Non-compliant toilet paper dispenser	-	Replace toilet dispenser as it does not allow continuous paper flow.	1	353	\$353
Access to Goods and Services												
32	Kindergarten Classroom	1	121	Doors, Doorways, & Gates	Classroom

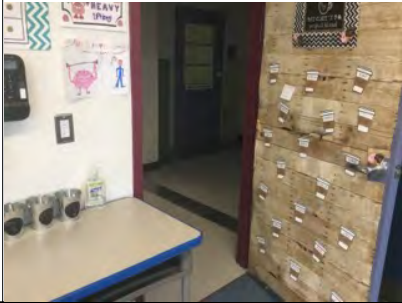
Maneuvering clearance(s) not provided	-	Relocate desk to ensure 18" clear on the latch pull side of the door.	1	Labor	\$0
Access to Goods and Services												
33	Kindergarten Classroom	1	121	Dining or Work Surfaces	Work Surface

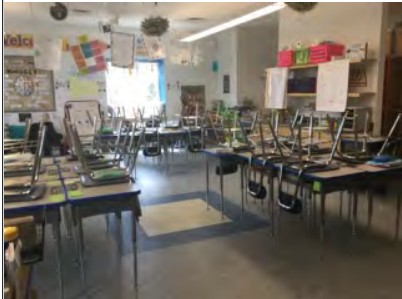
At least one or 5% accessible tables not provided Knee or toe clearance not provided	- 22" wide	Provide at least 1 work surface with 24" min. high, 30" min. wide knee and toe clearance.	1	350	\$350

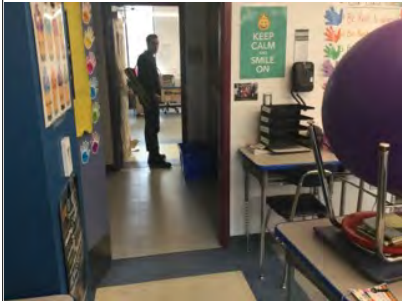
Maneuvering clearance(s) not provided	-	Relocate desk out of the required door maneuvering clearance.	1	Labor	\$0
Additional Access												
35	Kindergarten Classroom	1	122	Sink	Classroom

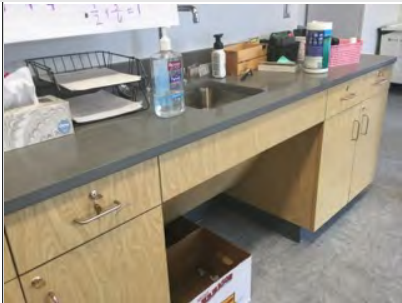
Toe and knee clearances not provided	-	Ensure there is knee clearance positioned for a forward approach by relocating the storage bin. 18" deep at the sink is not entirely compliant, but usable.	1	Labor	\$0
Access to Goods and Services												
36	Kindergarten Classrooms	1	122 121	Interior Access Route	N/A

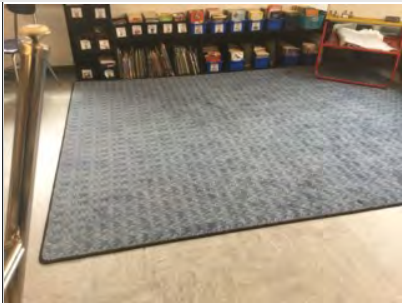
Surface not stable, firm, and slip-resistant	-	Securely attach mats.	3	Labor	\$0
Access to Goods and Services												
37	Corridor Near 116A	1	333	Interior Access Route	N/A

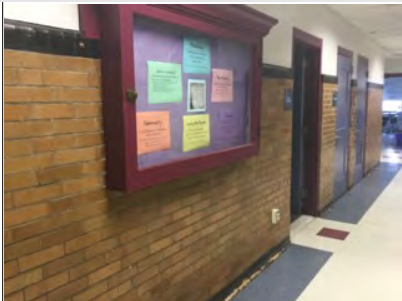
Obstructed by protruding objects	5.5"	Note: On March 22, 2018; The Massachusetts Office of Public Safety and Inspections Architectural Access Board granted relief for this condition.	2	-	\$0

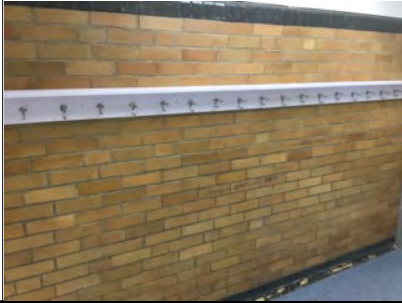
52"	Best Practice: Provide at least one hook is 36" maximum above the finished floor.	1	-	\$0
Additional Access												
39	Corridor by Stair 2	2	200	Drinking Fountains	Low

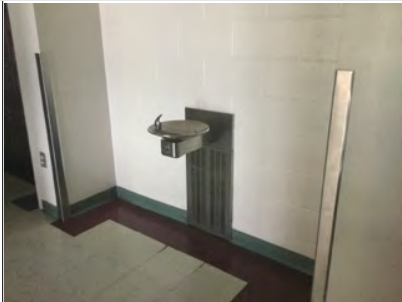
No drinking fountain provided for standing users	-	Provide an additional drinking fountain for standing users or install a Hi-Lo drinking fountain.	1	2014	\$2014
Access to Goods and Services												
40	Classroom 10	2	201B	Dining or Work Surfaces	Work Surface

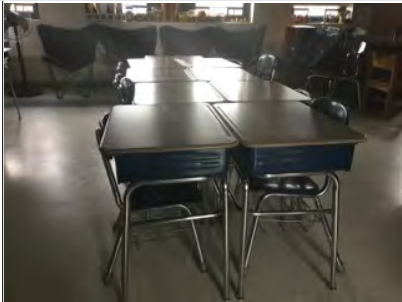
At least one or 5% accessible tables not provided Knee or toe clearance not provided	18" wide 21"	Provide at least 1 work surface with 24" min. high, 30" min. wide knee and toe clearance.	1	350	\$350
41	Classroom 10	2	201B	Interior Access Route	N/A

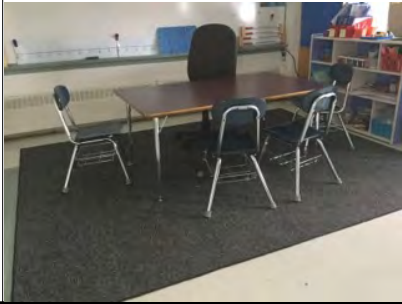
Surface not stable, firm, and slip-resistant	-	Securely attach mat.	1	Labor	\$0

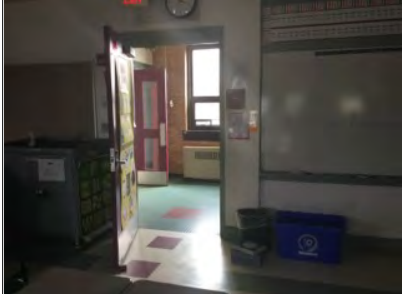
42	Classroom 10	2	201B	Doors, Doorways, & Gates	Classroom

Maneuvering clearance(s) not provided	-	Relocate trash bin to ensure 18" clear on the latch pull side of the door.	1	Labor	\$0

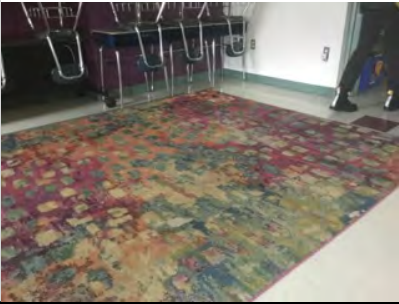
Surface not stable, firm, and slip-resistant	-	Securely attach mat.	1	Labor	\$0
Additional Access												
44	Classroom 11	2	202	Sink	Classroom

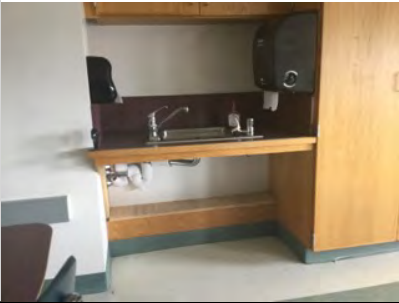
Toe and knee clearances not provided Exposed plumbing underneath sink	17" deep -	18" deep at the sink is not entirely compliant, but usable. Insulate or otherwise configure pipes at sink.	1	46	\$46
Access to Goods and Services												
45	Stair 1 From Classroom	2	202C	Signage	Egress

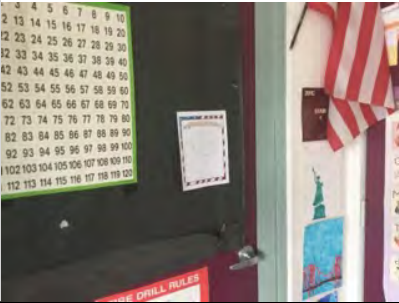
Not provided	-	Ensure that tactile egress signage is not obstructed by the flag.	1	Labor	\$0
Access to Goods and Services												
46	Learning Center, Room 1	2	203A	Interior Access Route	N/A

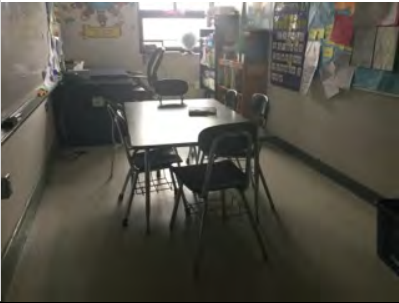
Route < 36" wide	23"	Ensure that a clear width of 36" min. is maintained at the accessible route. Relocate furniture.	1	Labor	\$0

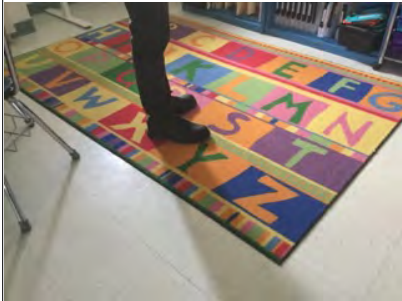
Surface not stable, firm, and slip-resistant	-	Securely attach mat.	1	Labor	\$0
Access to Goods and Services												
48	Science Room	2	206A	Interior Access Route	N/A

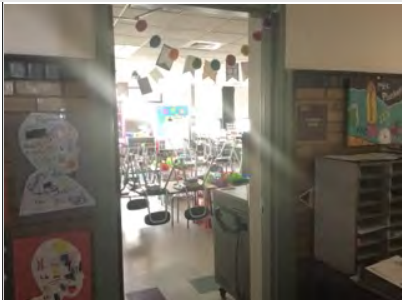
Obstructed by protruding objects	-	Relocate decorations hanging in the doorway out of the circulation path.	1	Labor	\$0
49	Science Room	2	206A	Doors, Doorways, & Gates	Classroom

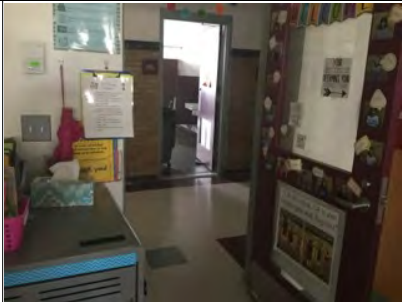
Maneuvering clearance(s) not provided	-	Relocate furniture to provide 18" clear on the latch pull side of the door.	1	Labor	\$0
50	Science Room	2	206A	Interior Access Route	N/A

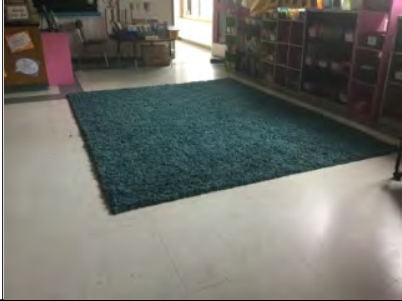
Surface not stable, firm, and slip-resistant	-	Securely attach all the mats in the room.	2	Labor	\$0
Additional Access												
51	Science Room	2	206A	Sink	Classroom

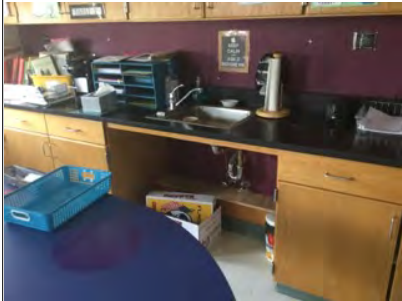
Clear floor space not provided at sink Toe and knee clearances not provided Exposed plumbing underneath sink	- 18" deep -	Relocate furniture to provide a 30" by 48" clear floor space positioned for a forward approach at the sink. Ensure there is knee clearance positioned for a forward approach by relocating the storage bins. 18" deep at the sink is not entirely compliant, but usable. Insulate or otherwise configure pipes at sink.	1	Labor 46	\$46

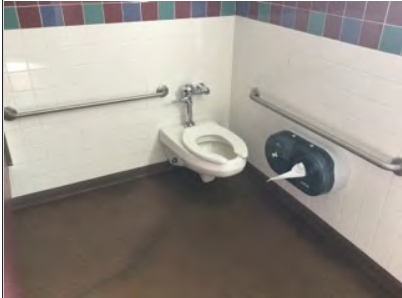
Door with malfunctioning self-closing hinge Non-compliant toilet paper dispenser	- -	Repair self-closing hinge. Replace toilet paper dispenser as it does not allow continuous paper flow.	1	353 Labor	\$353
53	Girls' Toilet Room by 202B	2	207	Dispensers	Paper Towel Dispenser

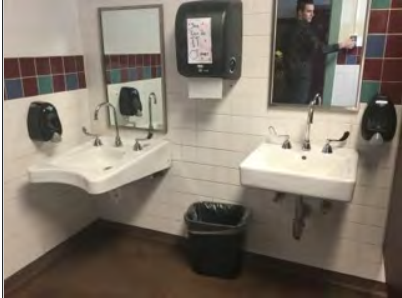
Dispenser controls > 42" high Dispenser not operable with a closed fist	47.45" -	Relocate paper towel dispenser so the operable part is 42" max. above the finished floor. Provide a paper towel dispenser that can be operable with one hand and not require tight grasping, pinching, or twisting of the wrist.	1	453	\$453
Access to Goods and Services												
54	Art Room	2	207B / 213	Doors, Doorways, & Gates	Classroom

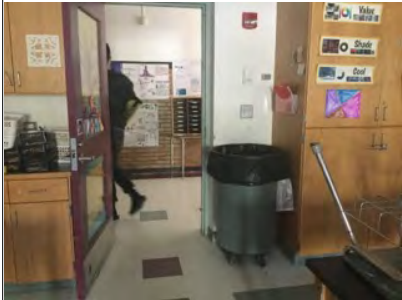
Maneuvering clearance(s) not provided	-	Relocate trash can to ensure 18" clear on the latch side of the door.	1	Labor	\$0

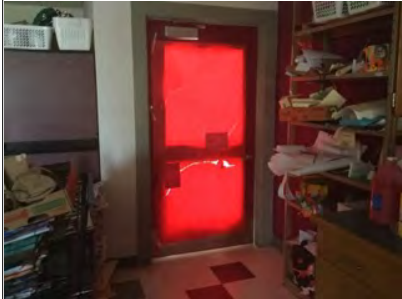
55	Art Room	2	207B / 213	Doors, Doorways, & Gates	Classroom

Maneuvering clearance(s) not provided	-	Relocate furniture on the left side of the door to ensure there is 22" clear on the hinge side of the door.	1	Labor	\$0
Additional Access												
56	Art Room	2	207B / 213	Sink	Classroom

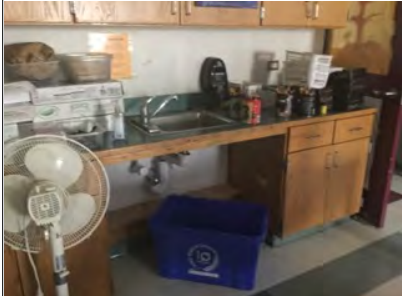
Toe and knee clearances not provided	18" deep	Ensure there is knee clearance positioned for a forward approach by relocating the recycling bin. 18" deep at the sink is not entirely compliant, but usable.	1	Labor	\$0

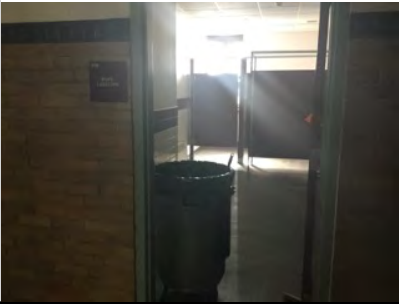
International Symbol of Acc. not compliant	-	Replace sign with a sign containing the International Symbol of Accessibility.	1	116	\$116
Toilet Rooms for Children												
58	Boys' Toilet Room	2	209	Toilet Compartment	Accessible Compartment

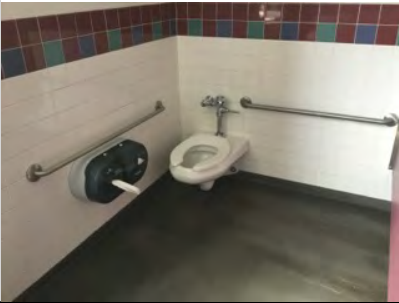
Non-compliant toilet paper dispenser	-	Replace toilet dispenser as it does not allow continuous paper flow.	1	353	\$353
Access to Goods and Services												
59	Classroom 12	2	209 / 212	Interior Access Route	N/A

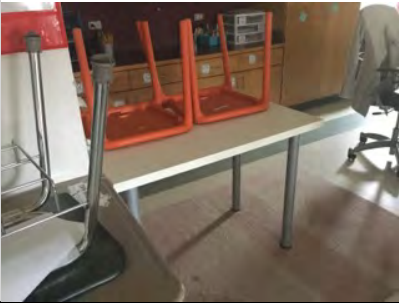
Surface not stable, firm, and slip-resistant	-	Securely attach mat.	1	Labor	\$0
60	Classroom 12	2	209 / 212	Doors, Doorways, & Gates	Classroom

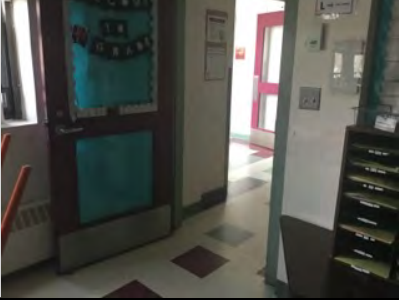
Maneuvering clearance(s) not provided	6"	Relocate items out of maneuvering clearance. Provide 18" clear on the latch pull side of the door.	1	Labor	\$0

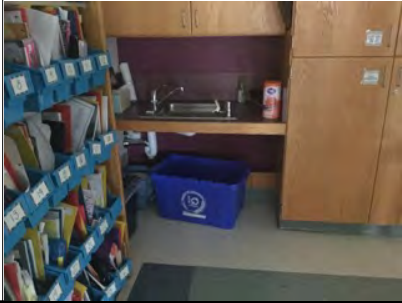
Toe and knee clearances not provided	18" deep	Ensure there is knee clearance positioned for a forward approach by relocating the recycling bin. 18" deep at the sink is not entirely compliant, but usable.	1	Labor	\$0
Toilet Rooms for Children												
62	Boys' Toilet Room	2	210 / 218	Toilet Compartment	Accessible Compartment

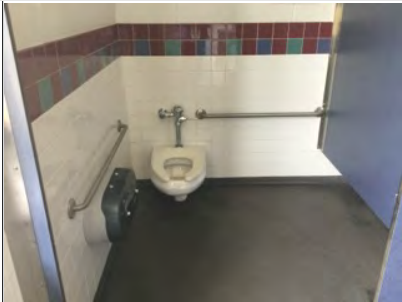
Door with malfunctioning self-closing hinge Non-compliant toilet paper dispenser	- -	Repair self-closing hinge. Replace toilet paper dispenser as it does not allow continuous paper flow.	1	Labor 353	\$353
63	Boys' Toilet Room	2	210 / 218	Dispensers	Paper Towel Dispenser

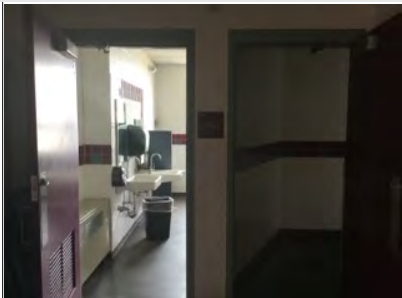
Best Practice												
64	Boys' Toilet Room	2	210 / 218

-	Best Practice: The sign for the boys' toilet room on the second floor is correctly placed but it is difficult to know which toilet room is which because the girls' and the boys' toilet rooms are side by side. Consider adding arrows to each sign.	1	-	\$0

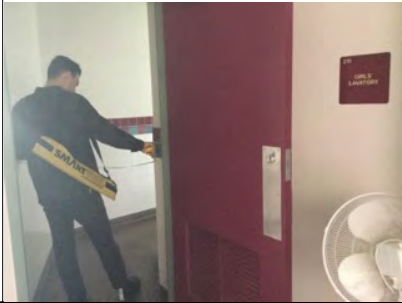
Maneuvering clearance(s) not provided	46" or less	Note: On March 22, 2018; The Massachusetts Office of Public Safety and Inspections Architectural Access Board granted relief for this condition.	1	-	\$0
Access to Goods and Services												
67	Classroom 13	2	212A / 220	Doors, Doorways, & Gates	Classroom

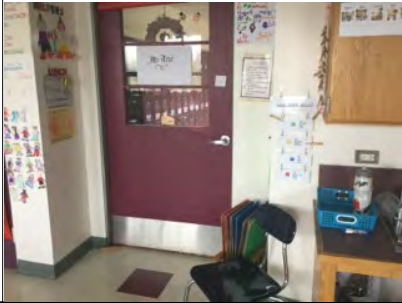
Maneuvering clearance(s) not provided	12"	Best Practice: Relocate items such as folder box to ensure 18" clear on the latch pull side of the door.	1	-	\$0

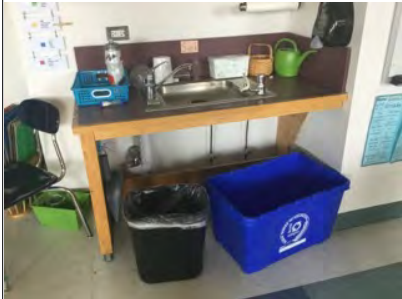
Additional Access												
68	Classroom 13	2	212A / 220	Sink	Classroom

Toe and knee clearances not provided	18" deep	Ensure there is knee clearance positioned for a forward approach by relocating the recycling bin and trash bin. 18" deep at the sink is not entirely compliant, but usable.	1	Labor	\$0

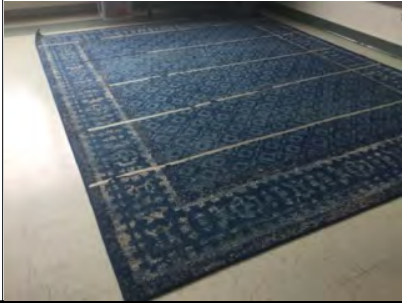
Surface not stable, firm, and slip-resistant	-	Securely attach all the mats in the room.	5	Labor	\$0
Access to Goods and Services												
70	Fourth Grade Classroom	2	212B	Dining or Work Surfaces	Work Surface

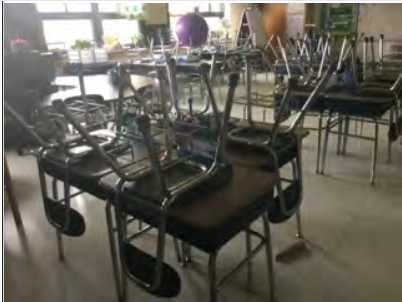
At least one or 5% accessible tables not provided Knee or toe clearance not provided	- 22" wide	Provide at least 1 work surface with 24" min. high, 30" min. wide knee and toe clearance.	1	350	\$350
71	Fourth Grade Classroom	2	212B	Doors, Doorways, & Gates	Classroom

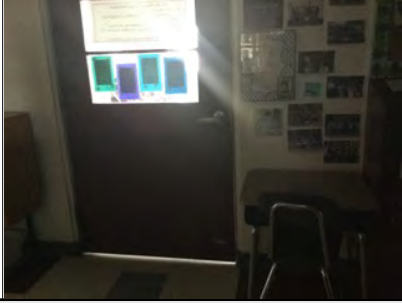
Maneuvering clearance(s) not provided	-	Relocate desk to ensure 18" clear on the latch pull side of the door.	1	Labor	\$0

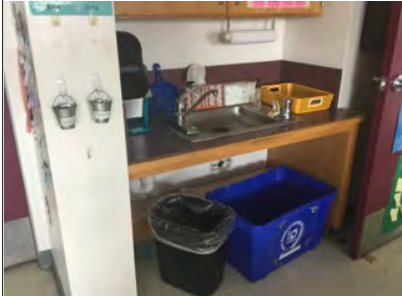
Additional Access												
73	Fourth Grade Classroom	2	212B	Sink	Classroom

Toe and knee clearances not provided Exposed plumbing underneath sink	- -	Relocate bins out of the clear floor space required at the sink. Insulate or otherwise configure pipes at sink.	1	Labor 46	\$46

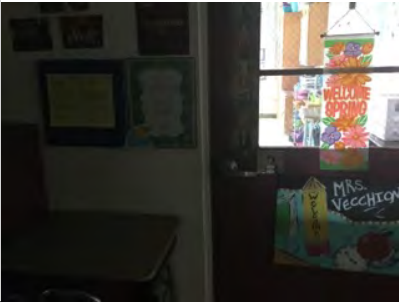
ID	Location	Floor	Room	Element	Type	Photo	Issues	Current Measure	Recommendations	Quantity	Price	Cost Estimation
Access to Goods and Services												
74	Classroom 15	2	214A / 222	Doors, Doorways, & Gates	Classroom

Maneuvering clearance(s) not provided	-	Relocate desk to ensure 18" clear on the latch pull side of the door.	1	Labor	\$0
75	Classroom 15	2	214A / 222	Interior Access Route	N/A

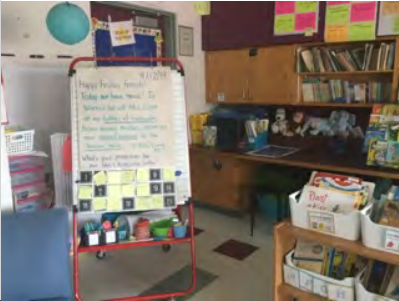
Route < 36" wide	29"	Ensure that a clear width of 36" min. is maintained at the accessible route. Relocate furniture.	1	Labor	\$0
76	Classroom 15	2	214A / 222	Doors, Doorways, & Gates	Classroom

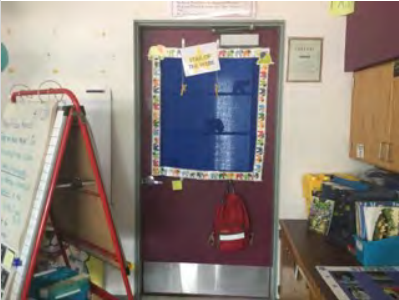
Maneuvering clearance(s) not provided	-	Relocate stand to ensure 24" clear on the latch pull side of the door.	1	Labor	\$0
Additional Access												
77	Classroom 15	2	214A / 222	Sink	Classroom

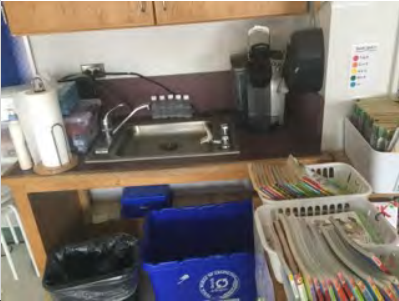
Clear floor space not provided at sink Toe and knee clearances not provided	- -	Relocate furniture to provide a 30" by 48" clear floor space positioned for a forward approach at the sink. Ensure there is knee clearance positioned for a forward approach by relocating the storage bins. 18" deep at the sink is not entirely compliant, but usable.	1	Labor	\$0

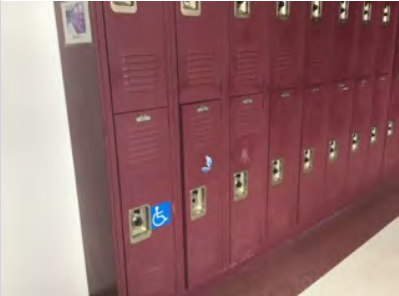
Access to Goods and Services												
78	Locker by 214B and Throughout School	2	214B	Locker Room	N/A

Total # of locker Total # of accessible locker 5% of lockers are not accessible	394 5 15	Provide 15 additional accessible lockers to ensure that 5% of all lockers are accessible .	15	128	\$1920

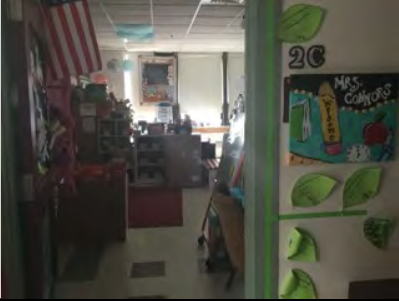
ID	Location	Floor	Room	Element	Type	Photo	Issues	Current Measure	Recommendations	Quantity	Price	Cost Estimation
Access to Goods and Services												
79	Classroom 17	2	216A / 215	Signage	Designation

Not provided	-	Sign is covered up. Relocate painting.	1	Labor	\$0
80	Classroom 17	2	216A / 215	Interior Access Route	N/A

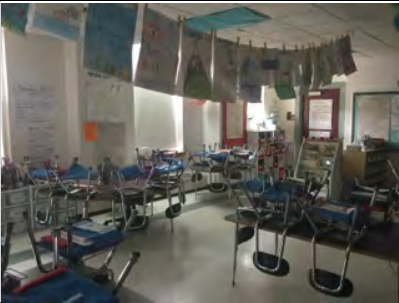
Obstructed by protruding objects	67"	Relocate paintings to be 80" high min.	1	Labor	\$0
81	Classroom 17	2	216A / 215	Doors, Doorways, & Gates	Classroom

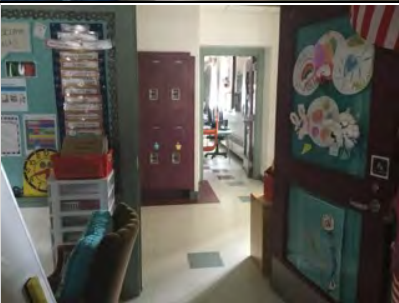
Maneuvering clearance(s) not provided	-	Relocate items out of maneuvering clearance. Provide 18" clear on the latch pull side of the door.	1	Labor	\$0
Additional Access												
82	Classroom 17	2	216A / 215	Sink	Classroom

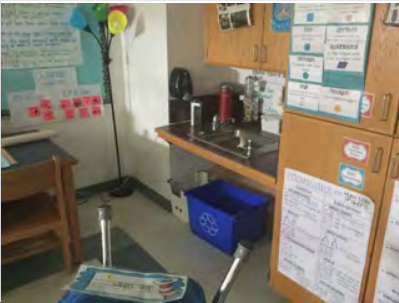
Clear floor space not provided at sink Toe and knee clearances not provided	- 18" deep	Relocate furniture to provide a 30" by 48" clear floor space positioned for a forward approach at the sink. Ensure there is knee clearance positioned for a forward approach by relocating the recycling bin. 18" deep at the sink is not entirely compliant, but usable.	1	Labor	\$0

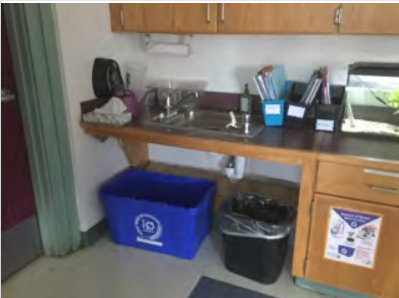
Additional Access												
83	Classroom	2	217A	Sink	Classroom

Exposed plumbing underneath sink Toe and knee clearances not provided	- -	Ensure there is knee clearance positioned for a forward approach by relocating the bins. Insulate or otherwise configure pipes at sink.	1	Labor 46	\$46

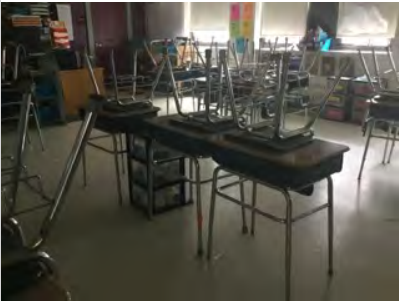
ID	Location	Floor	Room	Element	Type	Photo	Issues	Current Measure	Recommendations	Quantity	Price	Cost Estimation
Access to Goods and Services												
84	Fourth Grade Classroom 18	2	217A	Dining or Work Surfaces	Work Surface

Knee or toe clearance not provided	22" wide	Provide at least 1 work surface with 24" min. high, 30" min. wide knee and toe clearance.	1	350	\$350
85	Fourth Grade Classroom 18	2	217A	Dining or Work Surfaces	Work Surface

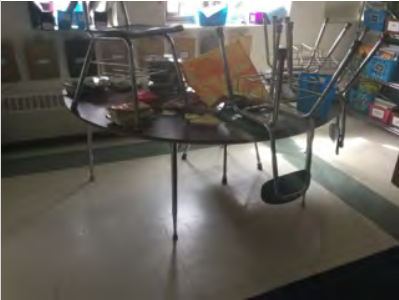
At least one or 5% accessible tables not provided	22.5"	Ensure that at least one work surface is accessible with 24" high of knee and toe clearance min.	1	350	\$350
Access to Goods and Services												
86	Classroom 18 Classroom 17	2	217A 216A	Interior Access Route	N/A
